# Fall Hazard Recognition Instructor Copy

Is This a Fall Hazard?

Photos in this presentation are from the OSHA Region 4 National Photo Archive and OSHA Region 5.

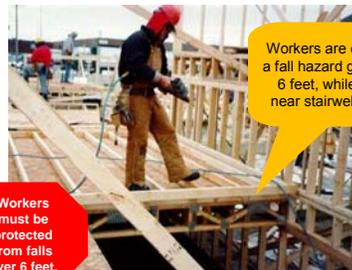
Workers are exposed to a fall hazard greater than 6 feet, while working near stairwell opening.

Workers must be protected from falls over 6 feet.

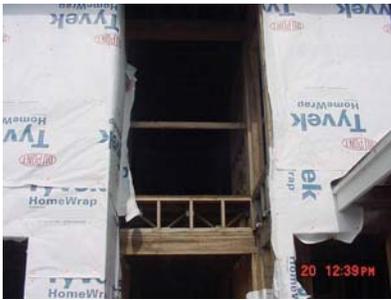
The photo shows a mid-rail and toeboard are missing on an open-sided floor of a building.

This could expose workers to a 12 foot fall.

Toeboards are required to protect workers below from falling objects.

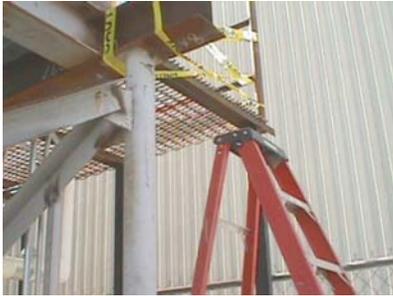
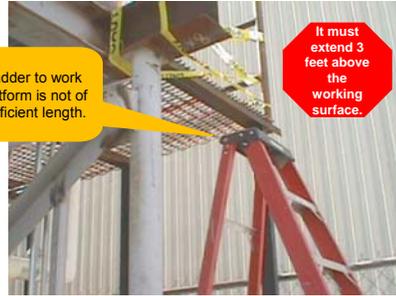
Ladder to work platform is not of sufficient length.

It must extend 3 feet above the working surface.

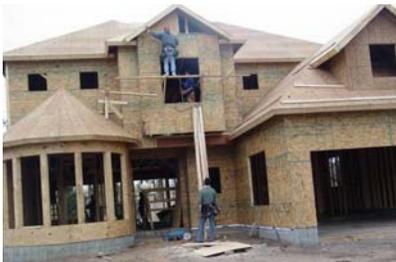
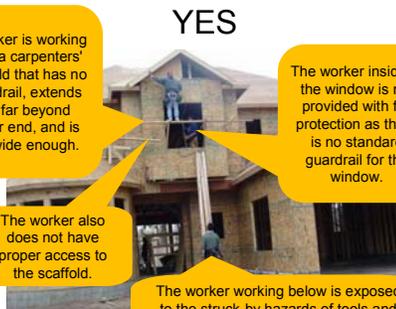
A worker is working from a carpenter's scaffold that has no guardrail, extends too far beyond either end, and is not wide enough.

The worker inside of the window is not provided with fall protection as there is no standard guardrail for the window.

The worker also does not have proper access to the scaffold.

The worker working below is exposed to the struck-by hazards of tools and equipment falling from the employees working above.

NOTE: A competent person must supervise as scaffolds are erected, moved and taken apart.

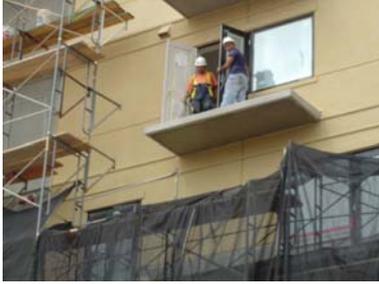
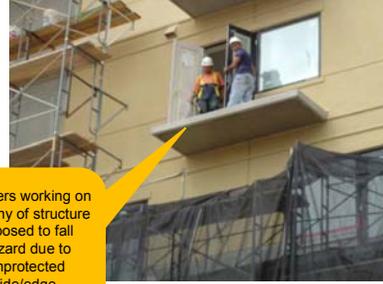
Workers working on balcony of structure exposed to fall hazard due to unprotected side/edge.

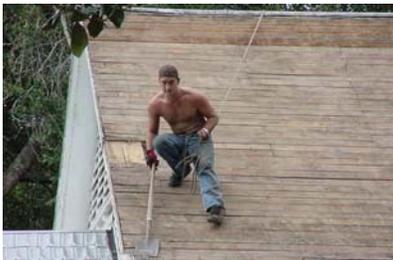
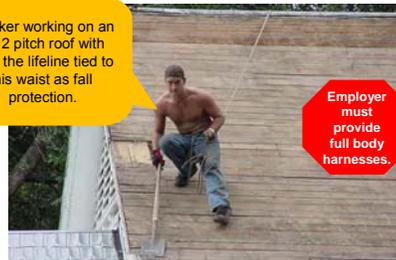
Worker working on an 8:12 pitch roof with only the lifeline tied to his waist as fall protection.

Employer must provide full body harnesses.

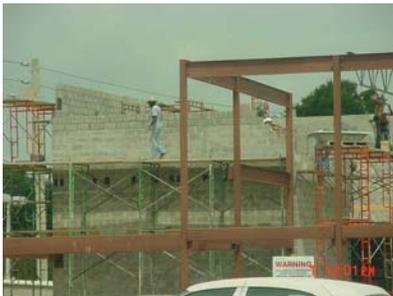
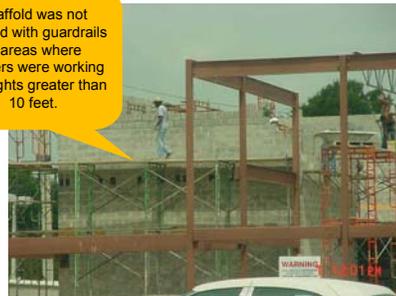
Scaffold was not erected with guardrails in areas where workers were working at heights greater than 10 feet.
