# Tragedy in the Trenches

**CASE STUDY #1**

## Fatality Investigation Report

### Construction worker killed when trench collapsed

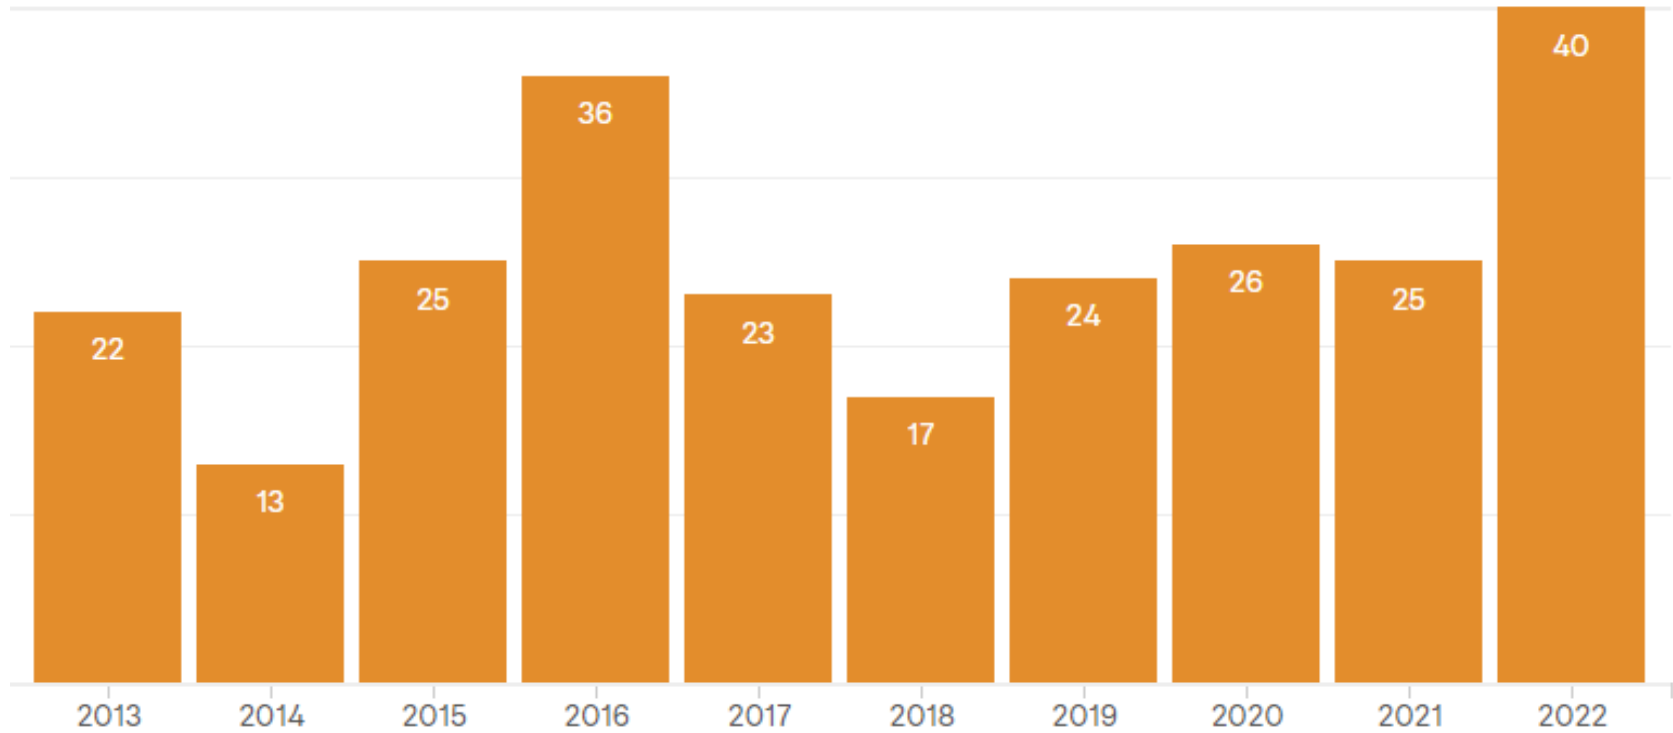
# Deaths from Trench Collapses 2013 – 2022

*Reference: Bureau of Labor Statistics and CPWR*

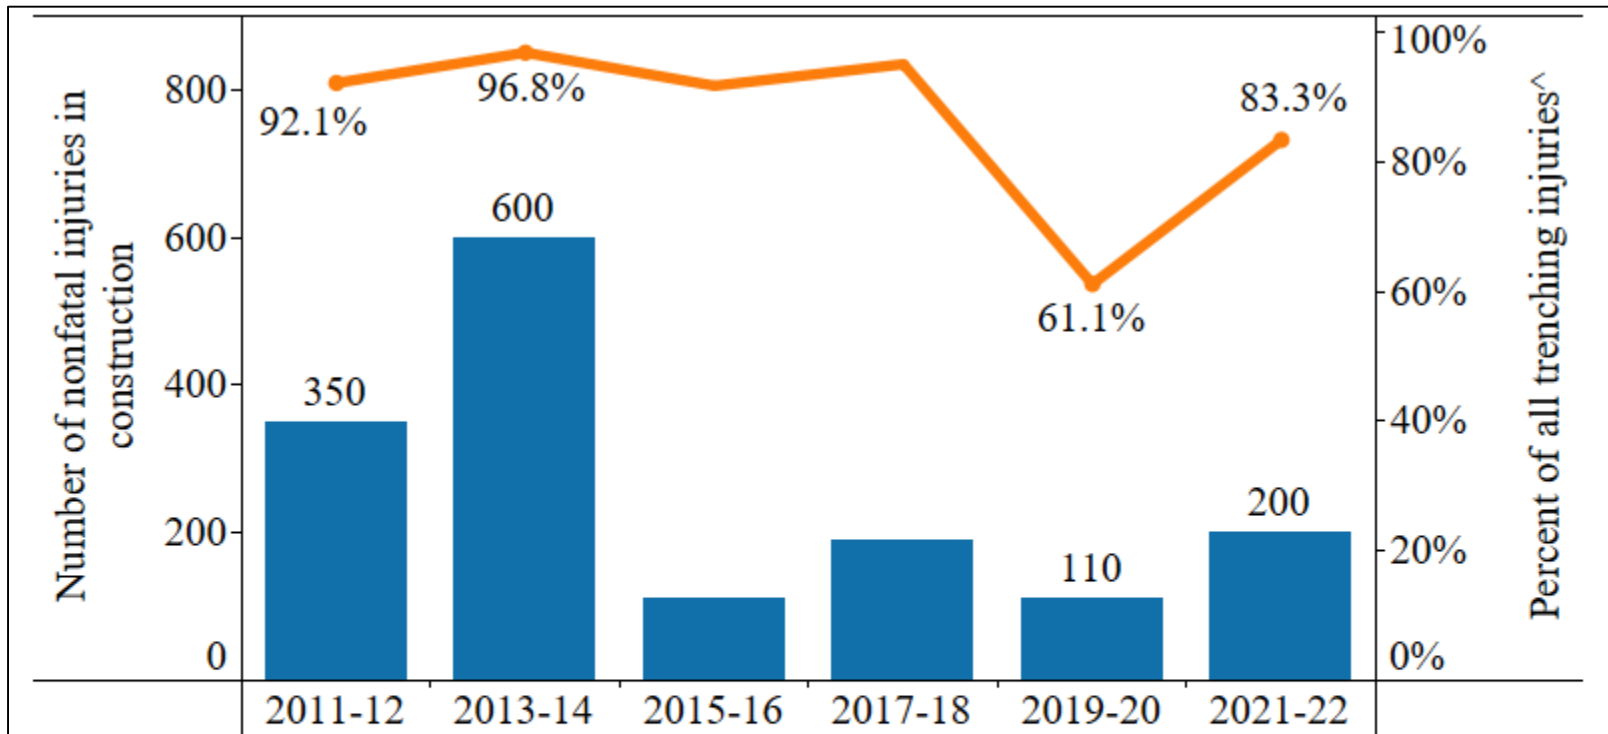
# Nonfatal Trenching Injuries 2011 – 2022

**Source:** U.S. Bureau of Labor Statistics, 2011-2022 Survey of Occupational Injuries and Illnesses. Calculations by the CPWR Data Center.

\*Sum is shown for each two-year period to produce comparable statistics following BLS data change to biennial estimates for 2021-2022.

<sup>^</sup>Calculated as Number of trenching injuries in construction / Number of trenching injuries in all industries.

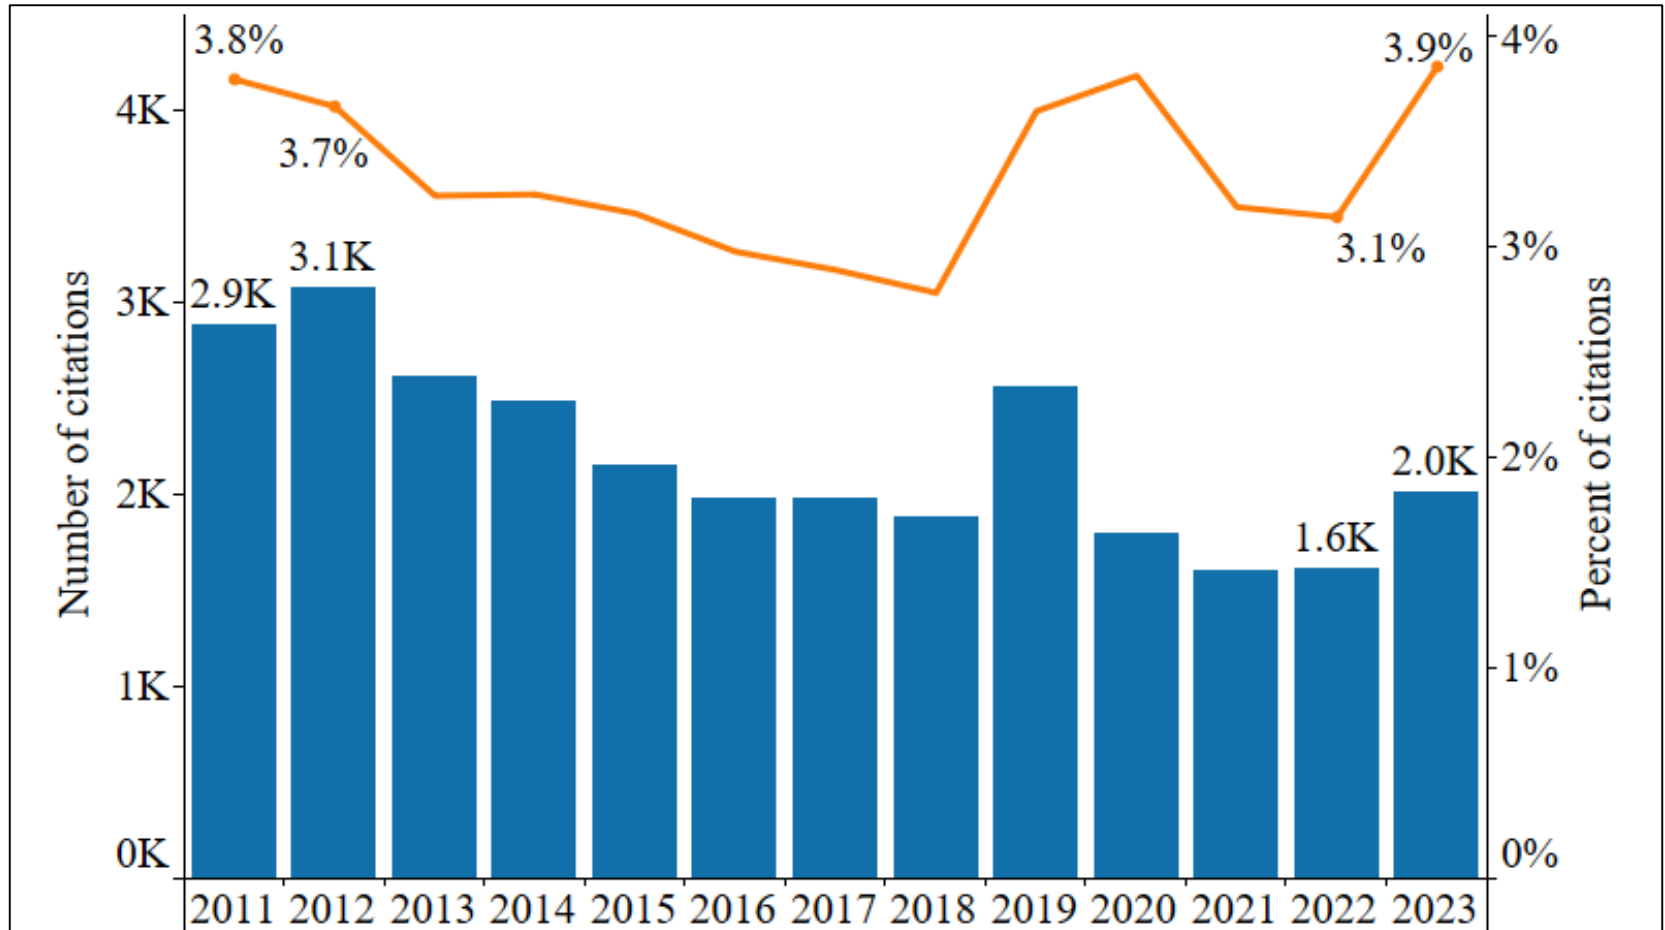
# OSHA Trenching Citations in Construction

**Source:** 2011-2023 Department of Labor OSHA Enforcement Data.  
Calculations by the CPWR Data Center.

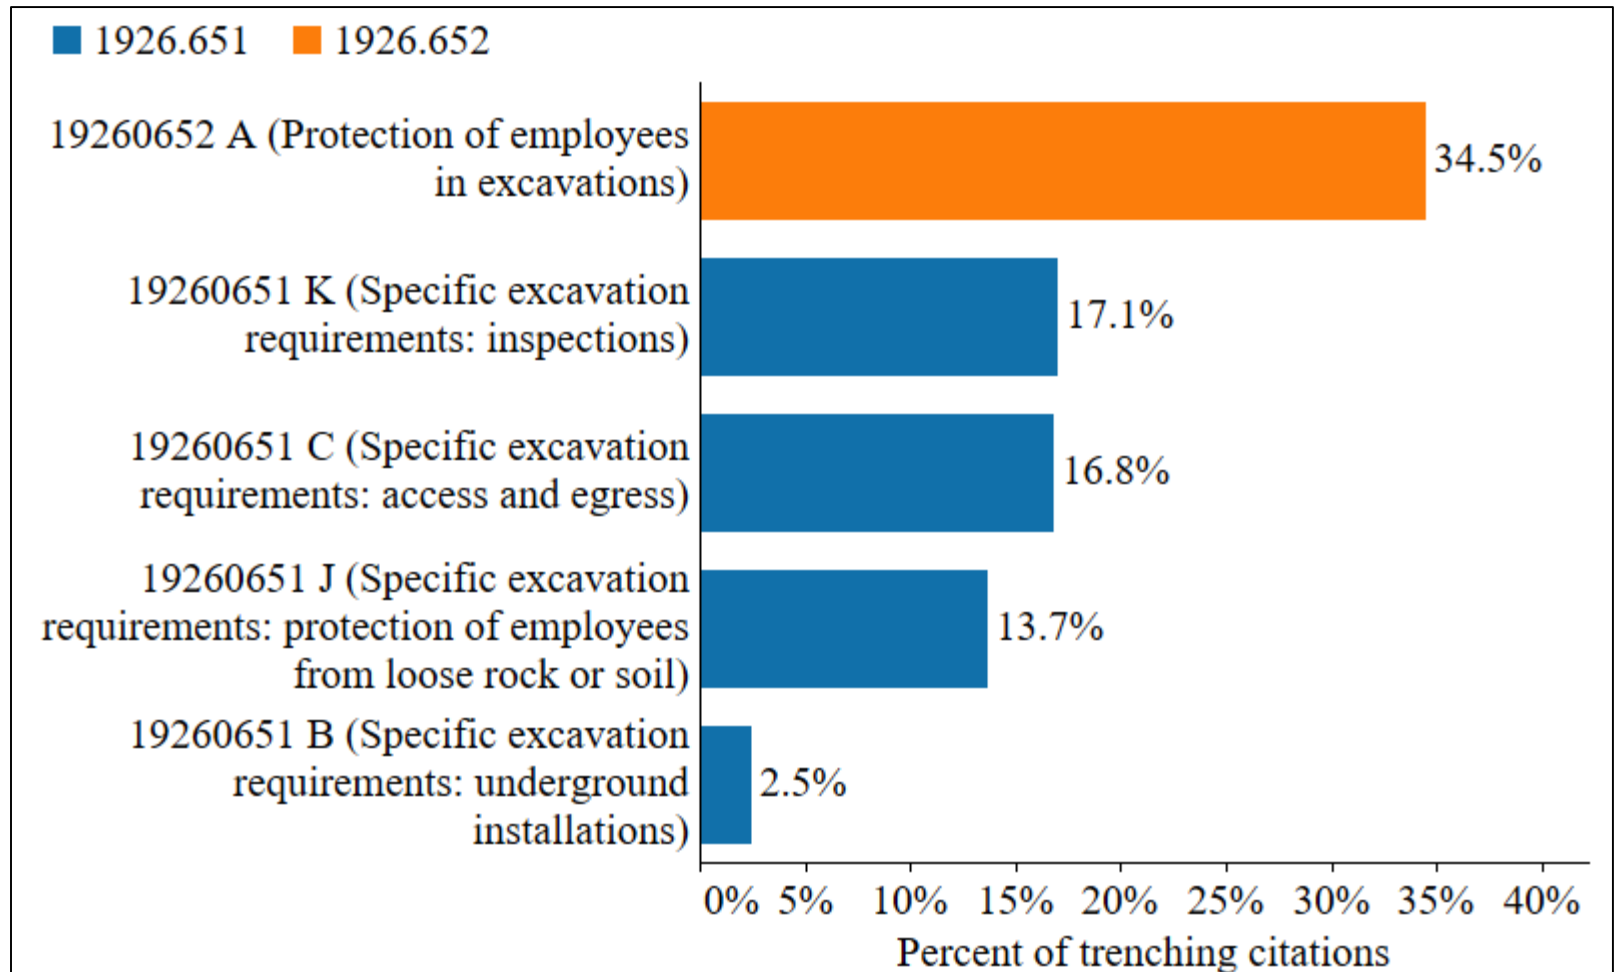
# Top 5 Cited Trenching Standards in Construction

**Source:** 2011-2023 Department of Labor OSHA Enforcement Data.  
Calculations by the CPWR Data Center.

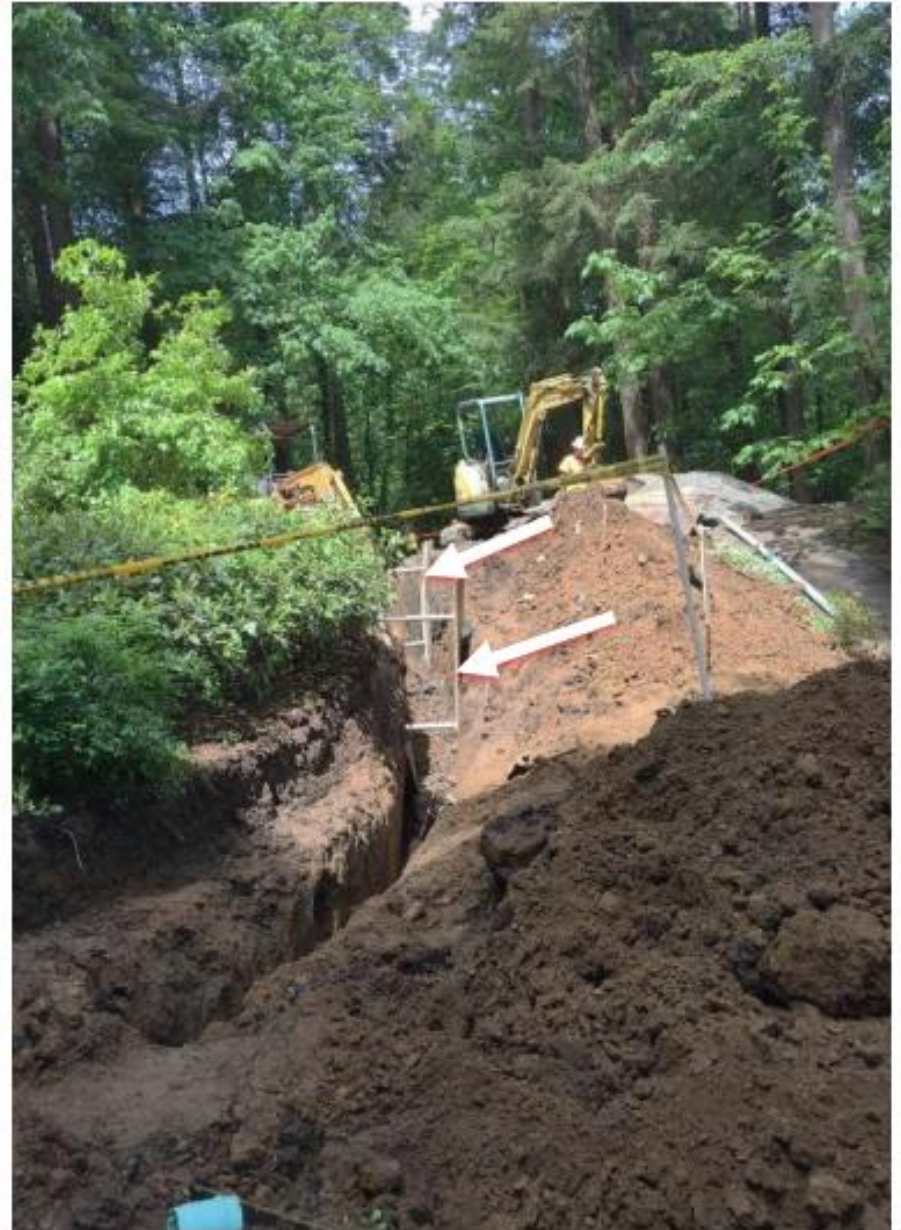
Figure 1. View from front of house: area of incident showing placement of shoring; collapse occurred in between the two pieces of shoring spaced 15 feet apart (indicated by arrows.)

On May 5, 2016, a 29-year-old construction worker employed by a small excavation contractor was killed when the trench he was working in collapsed and buried him in approximately 6 feet of dirt. The worker was part of a crew installing a sewer pipe at a residential property. The trench was 10 feet deep and approximately 3 feet wide in the area where the collapse occurred. The collapse occurred in an unprotected area of the trench, between two pieces of shoring that were spaced 15 feet apart (see Figure 1).

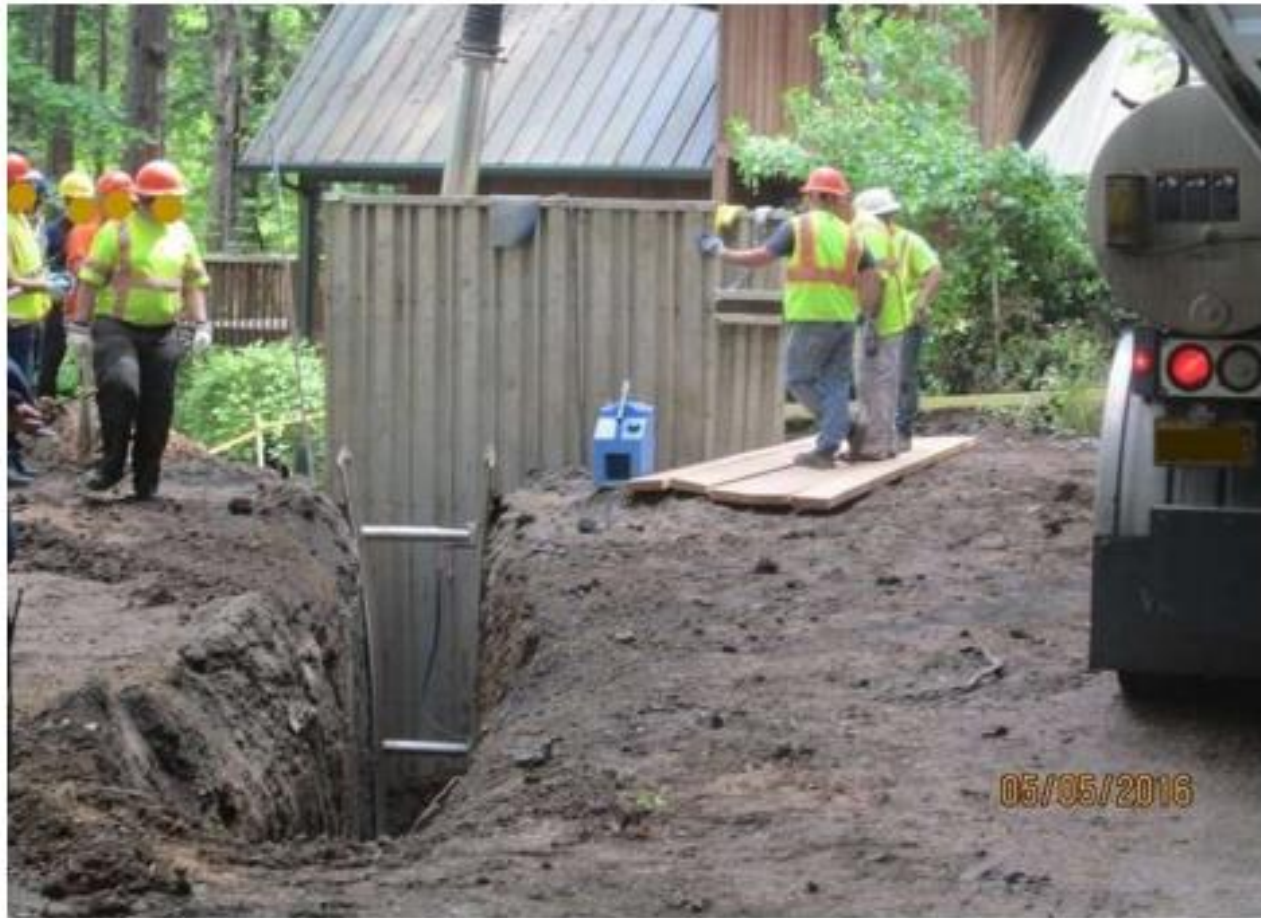
Figure 2. Emergency responders preparing to install a trench box before starting rescue and recovery work, to prevent risk of additional collapse and injuries

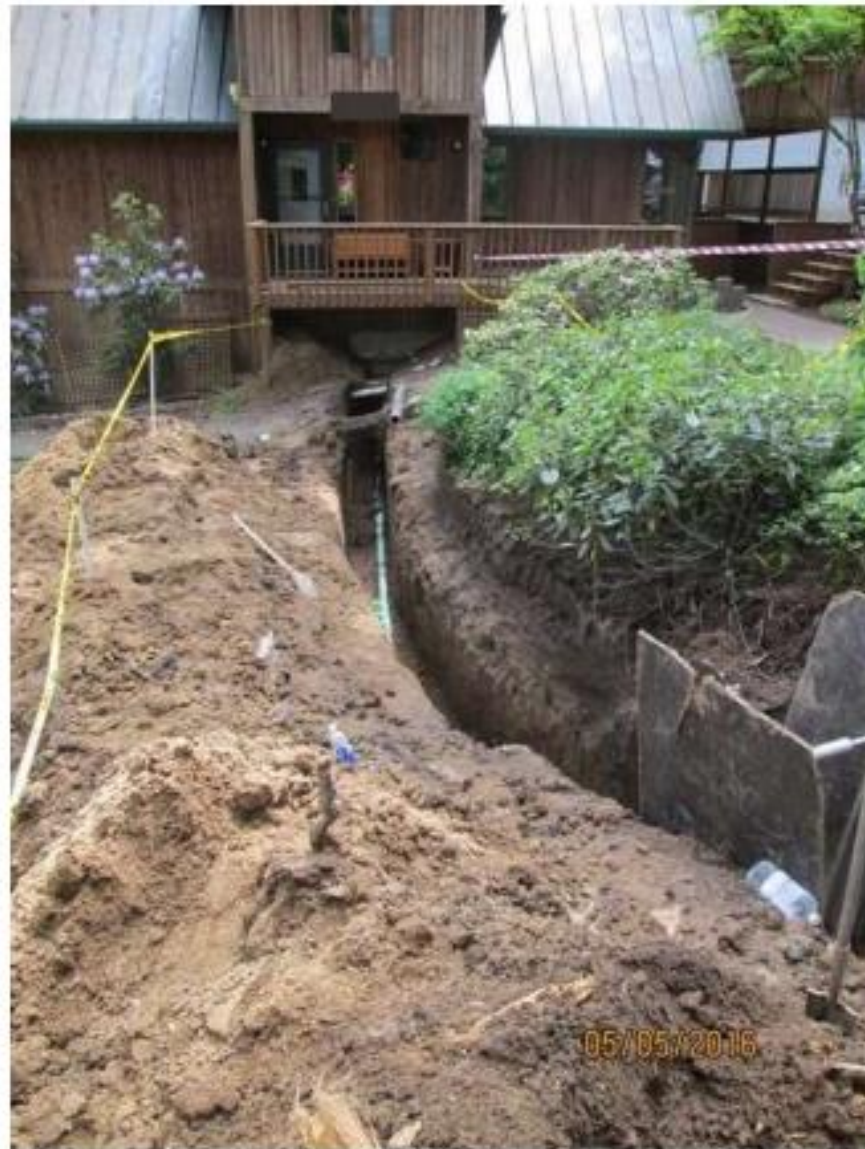
Figure 3. View of trench work area in front of house

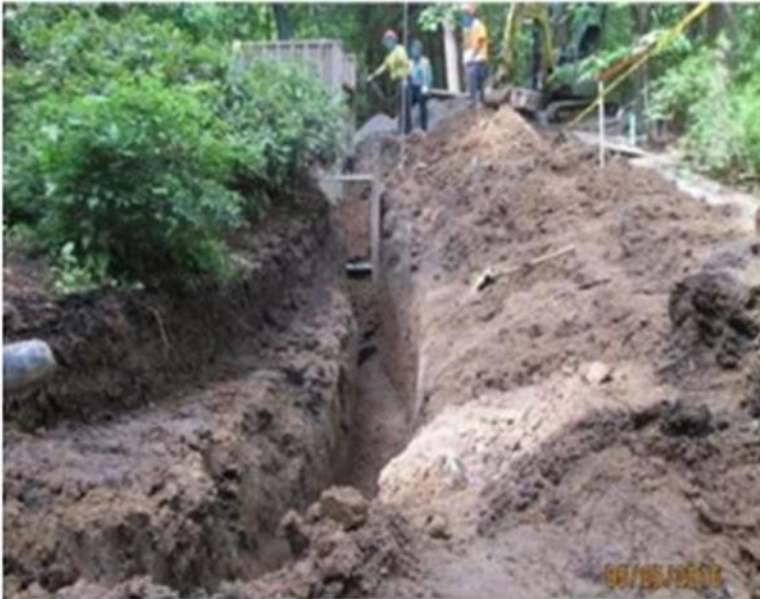
Figure 4. View from house showing trench work area and general soil conditions

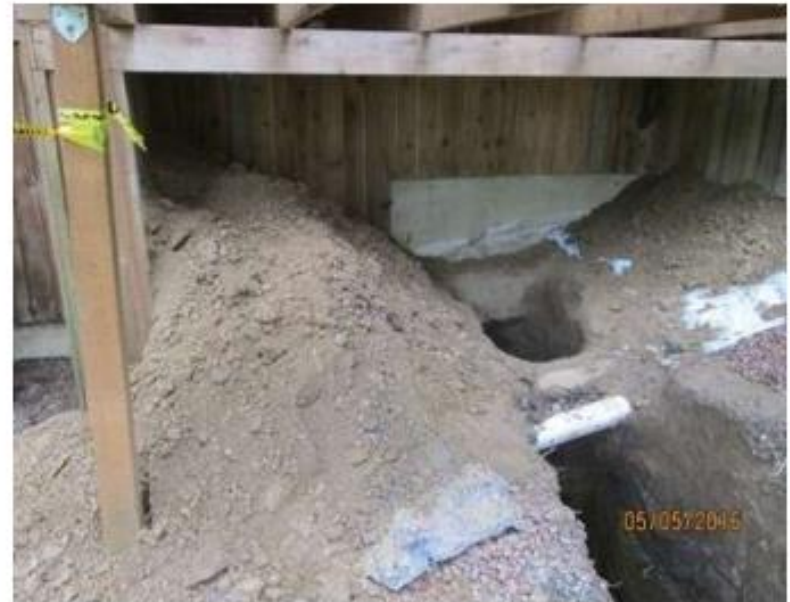
Figure 5. View of work area under deck of house where spoils had been placed at the open edge of the trench

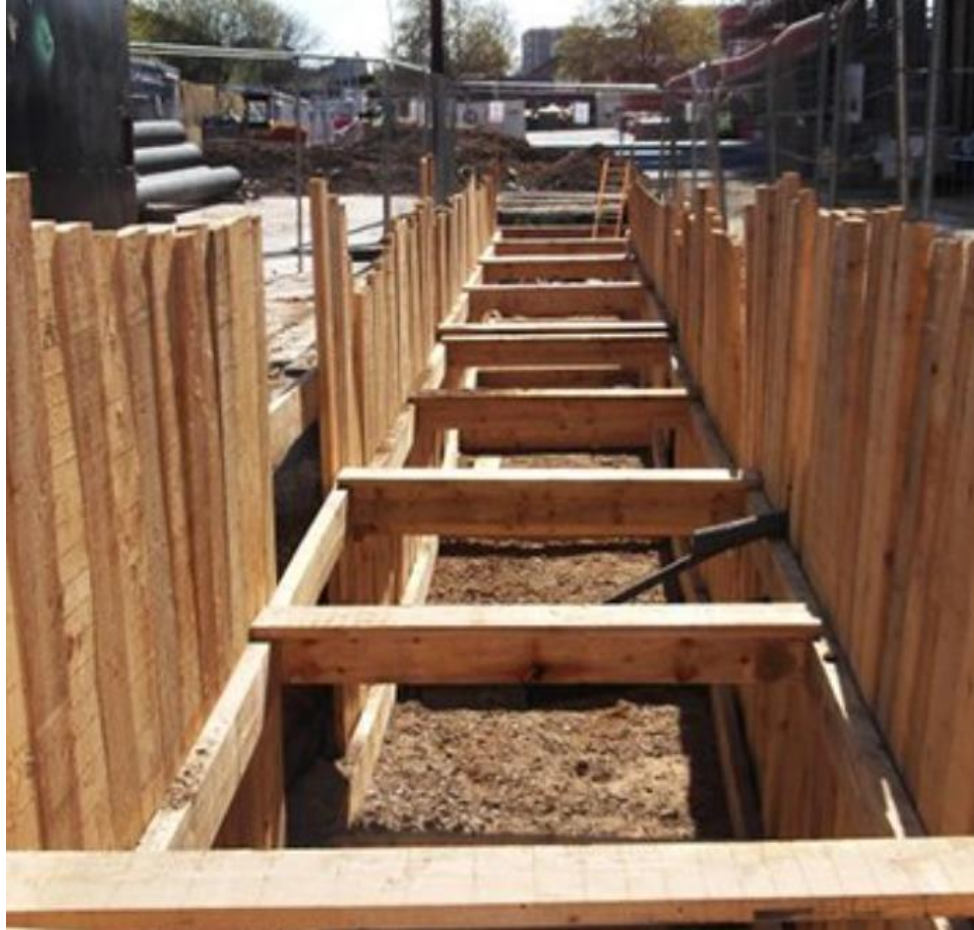
# Timber Shoring

**Must Meet OSHA Tables or RPE Design**

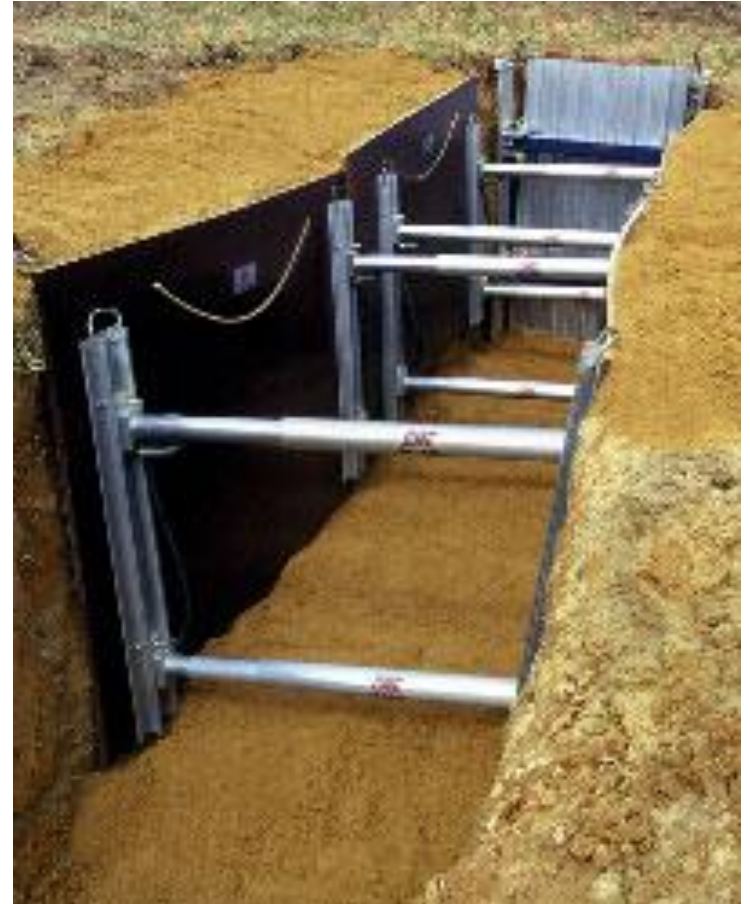
# Hydraulic Shoring

Hydraulic Aluminum Shoring

Tabulated Data  
Effective Dec. 4, 2007
